680/682 Synergy Indicator

Configuring Second Generation CPU Boards

Issue: The scale will not display weight due to reference error with 4-wire load cell connection

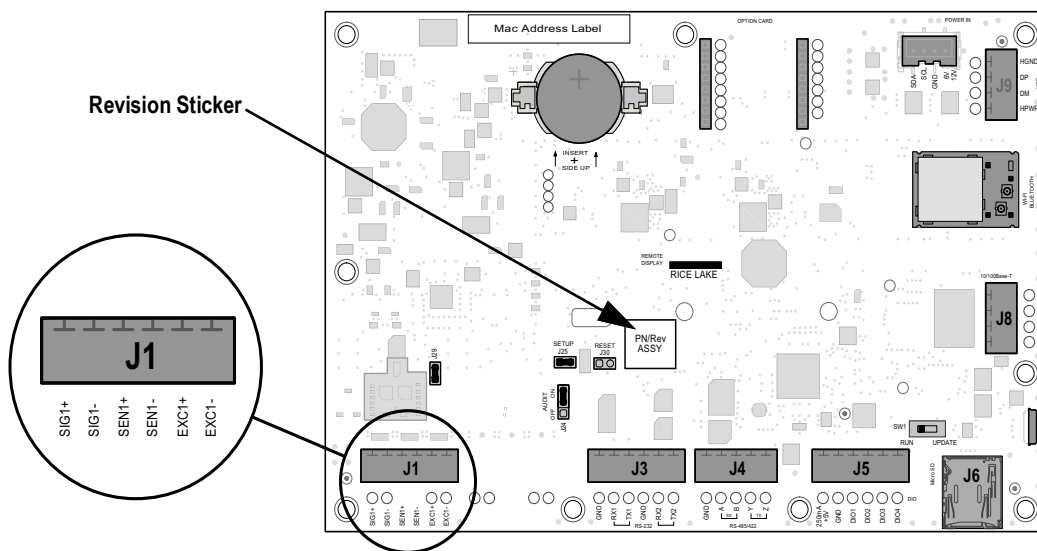
Figure 1. Revision Sticker Location

Locate the revision sticker on the CPU board as shown in [Figure 1](#).

IMPORTANT: To configure a second generation CPU board for a 4-wire connection, install a jumper wire between EXC+ and SEN+ and another jumper wire between EXC- and SEN-.
