iQUBE²® and 920i Fiber-Optic RX/TX Option

Restoring Fiber-Optic Connection

Products: iQUBE² Fiber-Optic Option (PN 77143) and 920i Fiber-Optic Option (PN 77788)

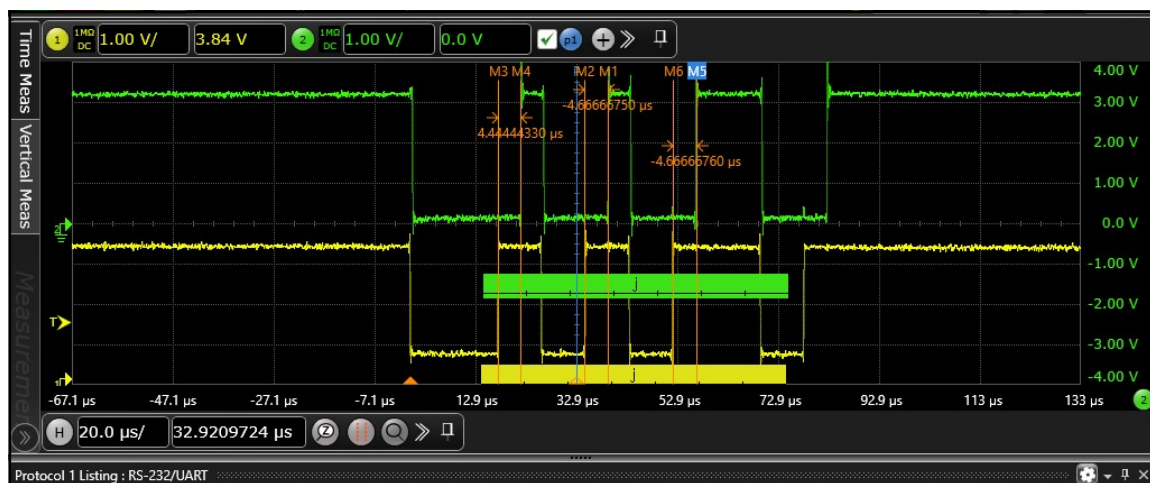
Figure 1. UART Timing Constraints at 115200 Baud

In short plastic fiber distances, the transmitter produces a high intensity light pulse. This causes the detector to remain in an active state after the light pulse has ended.

Also, baud rates exceeding 57600 can cause issues by tightening UART timing constraints while lower plastic fiber length decreases optical loss inside the fiber. Decreased optical loss increases intensity into the receiver which consequently increases the transmission delay (see Figure 1).
