Troubleshooting 920i® / iQUBE® Email Issues

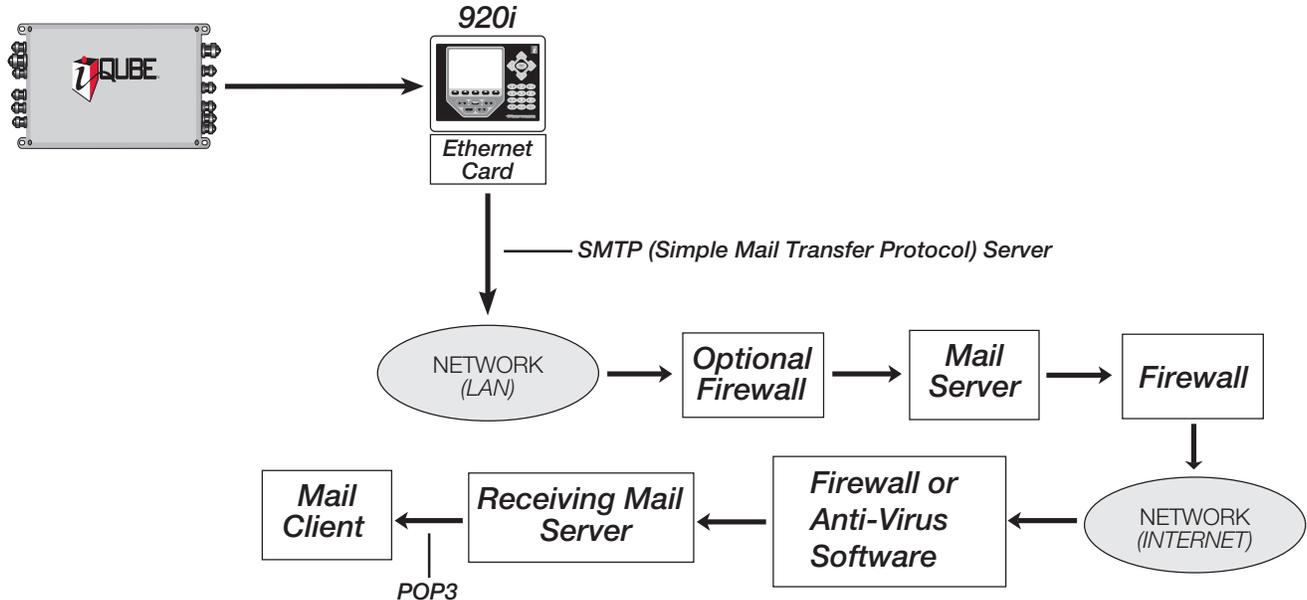
If you are having trouble connecting to your networked 920i, the problem might be caused by IP addressing or network firewall issues. First, see the below diagram for a typical network setup:

One of the most common problems is a firewall (or multiple firewalls). In many cases, the firewall simply doesn't know the Ethernet address of the 920i. Thus, it is rejected and can't make it past this point. The remedy is a firewall configuration by the company's IT department to add the 920i's address to the device.

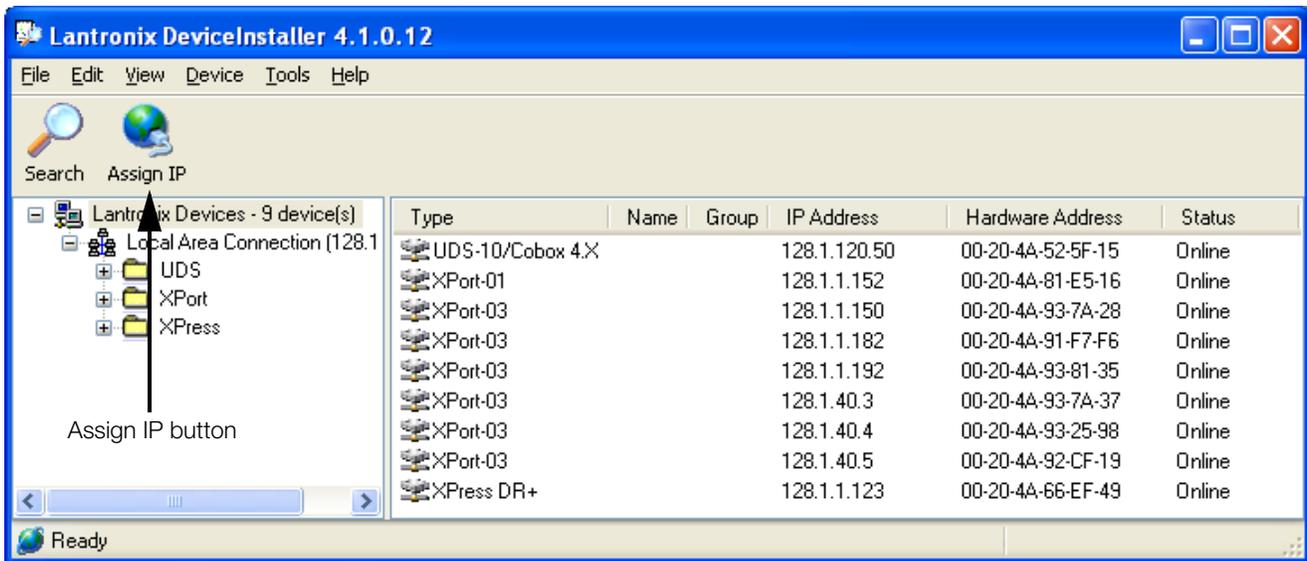
1. Insert the Ethernet Configuration CD and follow the Lantronix Device Installer on-screen instructions.
2. Start the Device Installer program.

- Using the *Hardware Address* column to determine which card is yours, locate your card and click on it.
- Click the Assign IP button as shown in the above illustration.

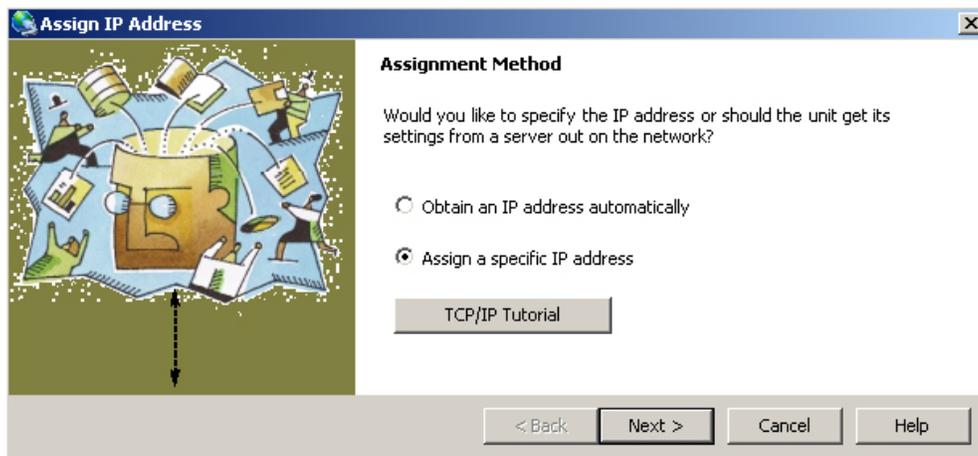
The *Assign IP Address* dialog box appears.

- Select *Assign a specific IP address* and click Next.

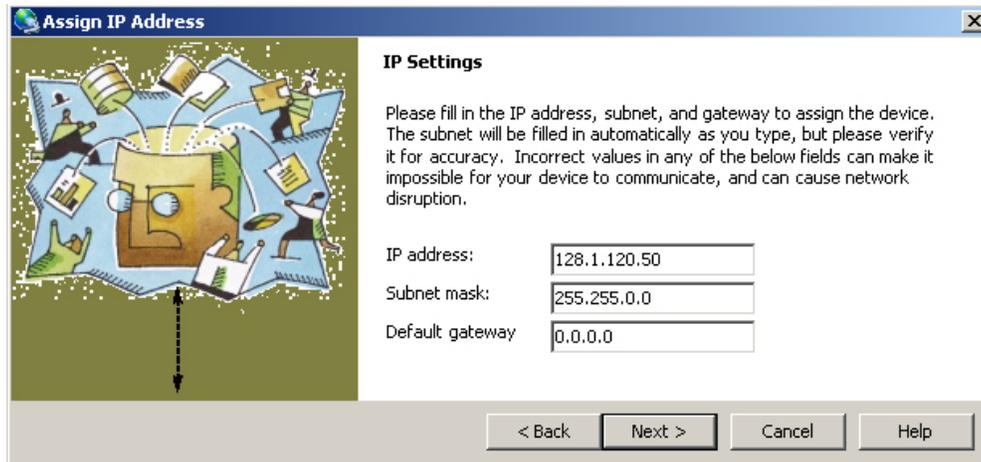
6. Type the IP address you would like to assign to the card, enter the Subnet mask and Default gateway, and click Next.
7. Click Assign to assign the IP address to the device.
A status message indicates when the assignment is complete.
8. To exit, click Finish.

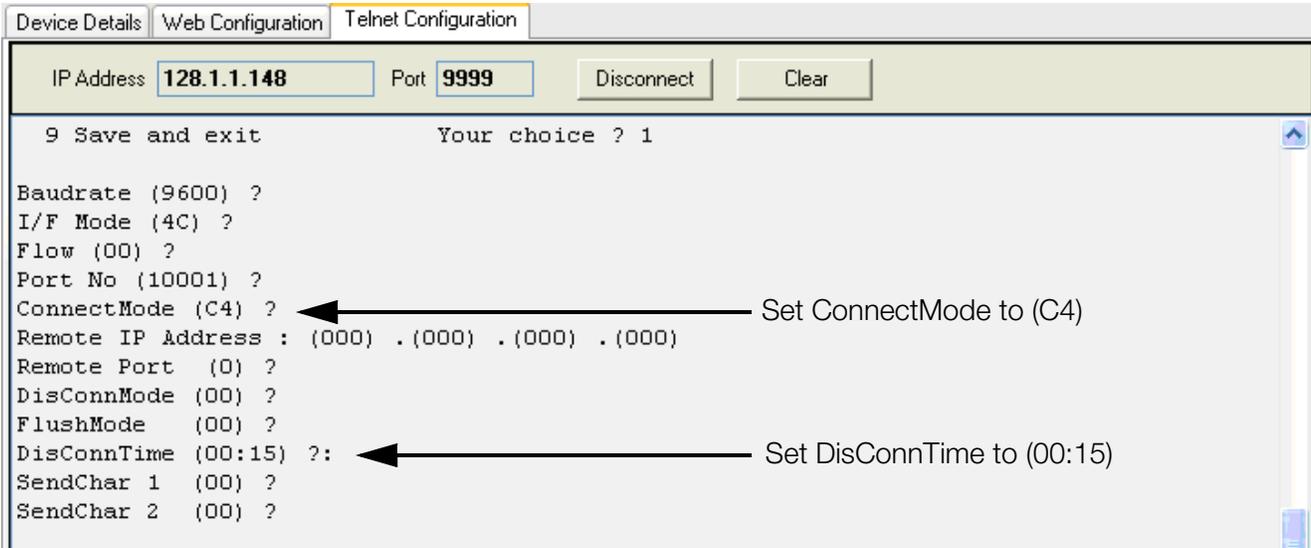
Telnet

The following screen shots illustrate correct settings in telnet and the Web configuration.

Set Active Connect to Manual Connection

Set Inactivity Timeout to 0:15

1. Configure the Lantronix card to the correct settings. This can be done via Web configuration or a telnet session on Port 9999 under *Channel 1 configuration*. If using telnet, it is recommended that you first default the card and then proceed with the following settings.
There are only three settings that need to be changed: *connection mode* needs to be set to C4 in telnet or Manual Connection using the Web interface; the *inactivity timer* needs to be set to 00:15; and the *alert port* must be set.

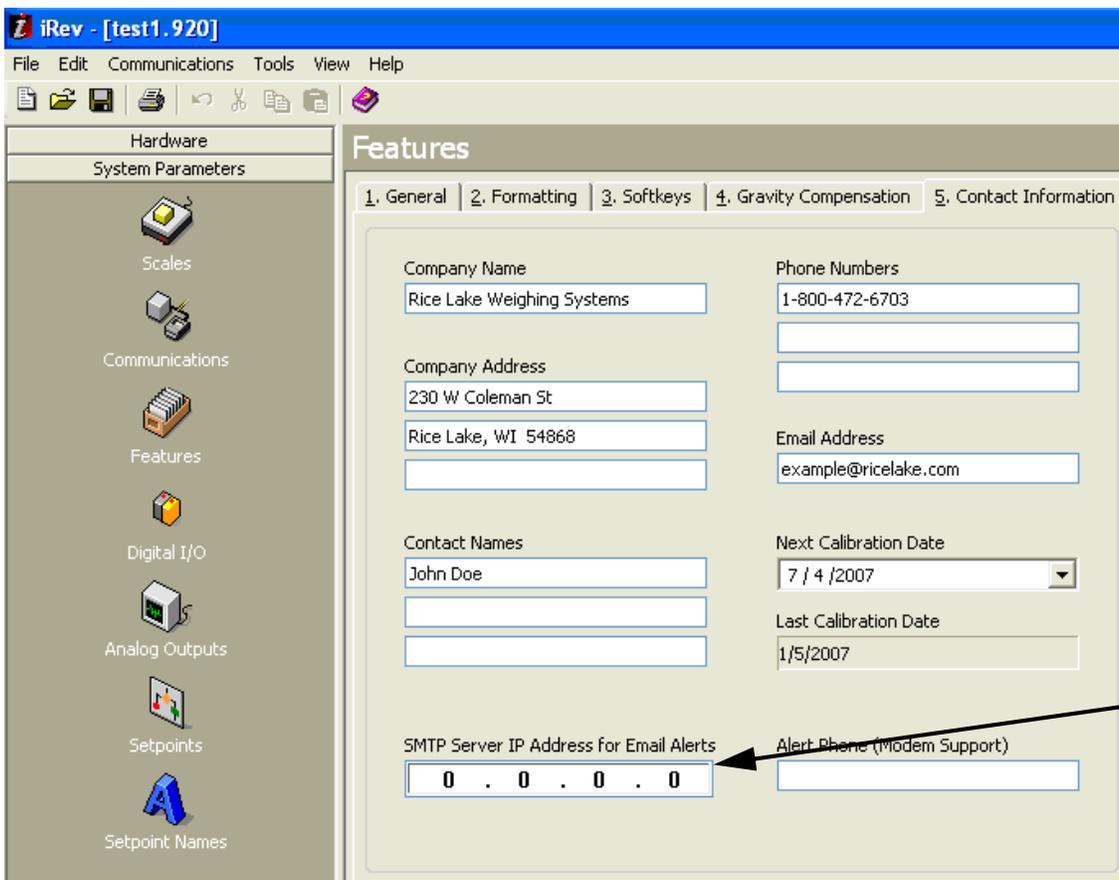
iRev settings

- In iRev, enter the SMTP address and desired email address. This parameter is found under System Parameters » Features » Contact Information tab. Only the SMTP address and email address are needed to get the system to mail an alert. The rest of the information is the contact info. The alert format port must be set to the port the Lantronix card is connected to.

- The *SMTP server address* must be set in the 920i. This value can be set in iRev or by using the ALERT.SERV serial command. The SMTP server address cannot be set using the 920i menus. To disable alert notification, set the SMTP server address to 0.0.0.0.

- The *alert contact email address* must be set to a valid address. This value can be set using the 920i menus (FEATURE menu, CONTACT submenu, email PARAMETER), through iRev or by using the CONTACT.EMAIL serial command.
- The *920i alert port* must be set to the port wired to the Ethernet card. This value can be set in iRev, by using the ALERT.PORT serial command, or by using the 920i front panel.

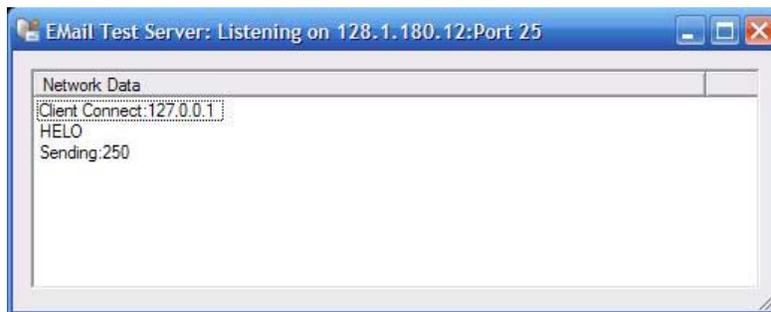
SMTP Test Server.

1. Visit www.ricelake.com and download the SMTP Test Server program.
2. Once the Email Test Server program is installed and running, set the appropriate server address on the 920i.
3. Intentionally generate an error.
4. The Email Test Server program will show data sent from the 920i, confirming whether the email is sent successfully.
